Investigation of Corrosion Caused by Iron Contamination on the Surface of Stainless Steel Plates

In our research, we compared four commonly used stainless material grades with different surface treatments. We investigated the effect of scratches left by carbon steel on the surface of the samples and the time course of the process.

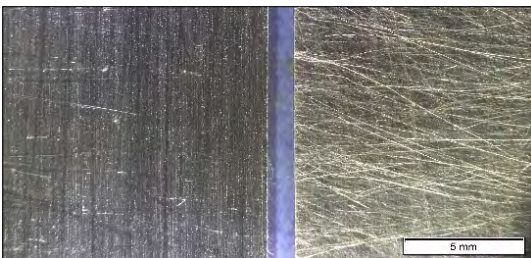
The test specimens were „contaminated” with iron particles in two different ways before the test. As shown in **Figure 1**, one specimen was wire-brushed and the other was scratched with a sharpened piece of carbon steel.

In the case of the wire brush, the scratches are shallower but more numerous on the sample surface, and iron oxide from the wire brush was also deposited on the sample surface. In the case of scratching with the carbon steel piece, the scratches are deeper and fewer in number.

Figure 1. Scratched (left) and wire-brushed surfaces, 2205 duplex, scale is 5 mm.

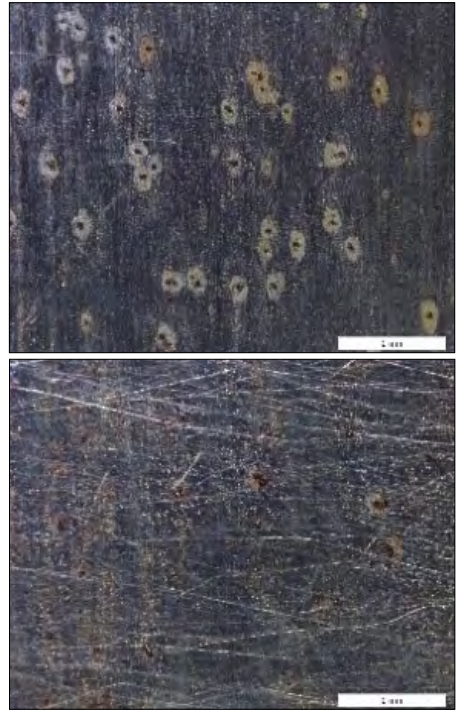
The surface of the 304 grade, polished surface-finished specimen shows significant changes after only two weeks. The scratched specimen shows dense surface pitting corrosion, while the wire-brushed specimen shows rusty discolouration and scattered surface pitting corrosion (**Figure 2**).

Figure 2. Scratched (upper) and wire-brushed 304 test specimens after two weeks, scale is 2 mm.

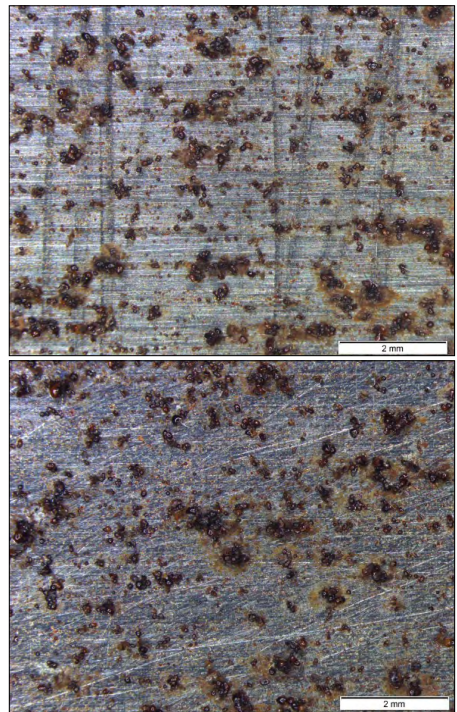
The same sample examined after two months is shown in **Figure 3**.

Figure 3. Scratched (upper) and wire-brushed 304 test specimens after two months, scale is 2 mm.

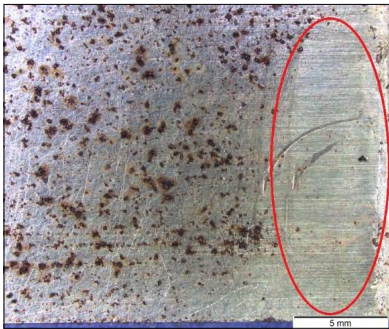
It can be clearly seen in **Figures 4** and **5**, that no discolouration or surface pitting has occurred on the masked surface. This phenomenon was observed in all test cases for each material grade tested.

Figure 4. The masked surface of the 304 specimen, after two months of exposure.

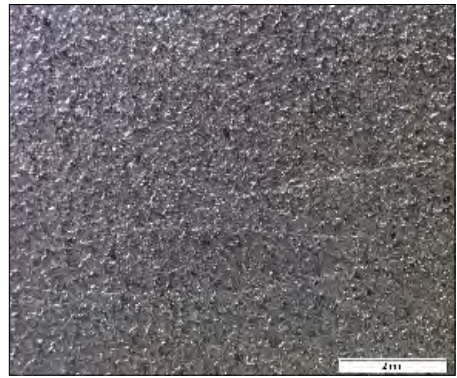
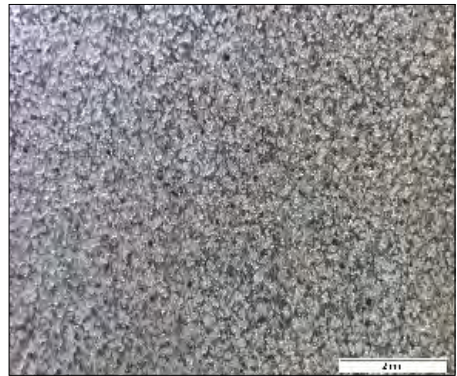
On the pickled surface of the 316L sample, after two weeks, only scattered rust discolouration is visible (**Figure 6**).

Figure 6. Scratched (left) and wire-brushed 316L test specimens after two weeks, the scale is 2 mm.

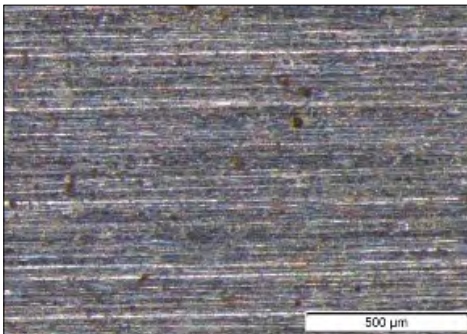
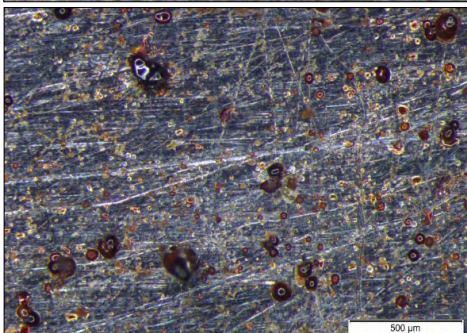
Figure 5. The masked (upper) and iron-contaminated surface of the 304 specimen after two months, the scale is 500 μm .

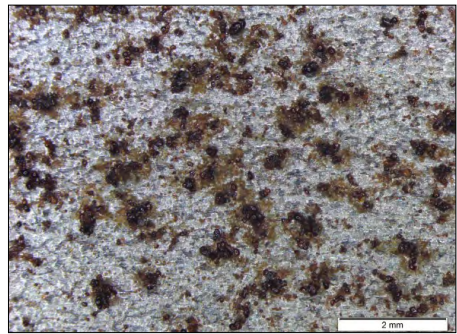
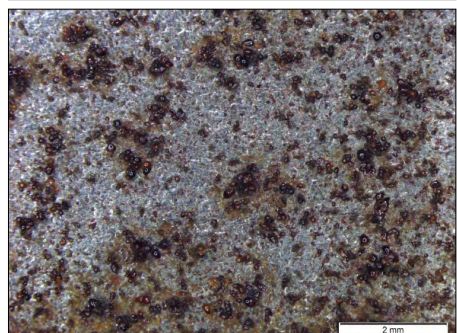
However, after two months, large amounts of rust deposits and surface pitting were observed on the sample surface (**Figure 7**).

Figure 7. Scratched (upper) and wire-brushed 316L test specimens after two weeks, the scale is 2 mm.

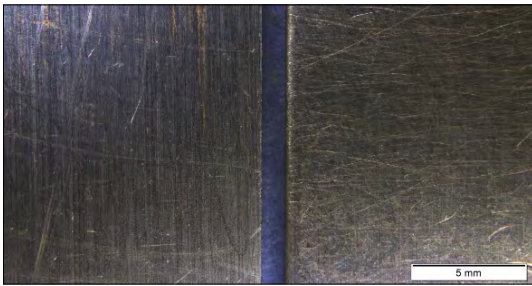
The surface finish of the 2205 duplex sample is brushed. In contrast to the other samples, the surface of this material shows a rusty discolouration only in the scratches (Figures 8–9).

Of the four material grades tested, this material has the highest pitting resistance index (PREN), as a result, there was no surface pitting corrosion observed in the sample, even at high magnifications.

Figure 8. Scratched (left) and wire-brushed 2205 specimens after two weeks, scale is 5 mm.

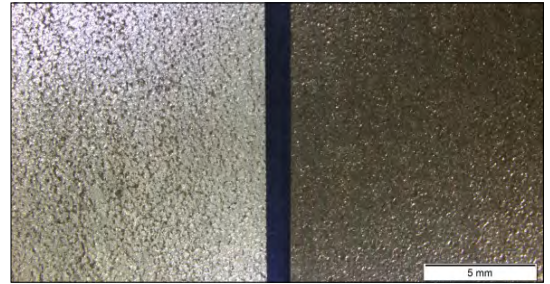
On the pickled surface of the 2304 duplex specimen, a rusty discolouration is visible in patches on the scratched specimen, and a more or less uniform rusty discolouration is visible on the wire brushed specimen (Figures 10–11. ábra).

Figure 10. Scratched (left) and wire-brushed 2304 specimens after two weeks, scale is 5 mm.

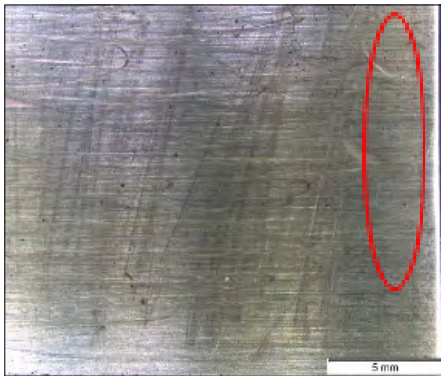
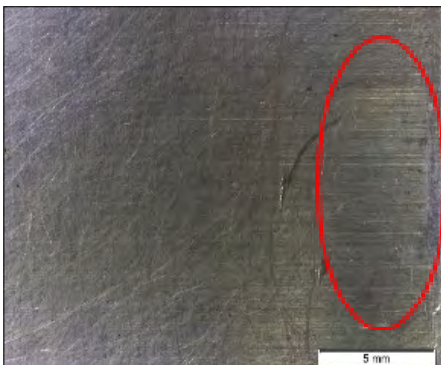
Figure 9. Scratched (upper) and wire-brushed 2205 specimens after two months, scale is 5 mm.

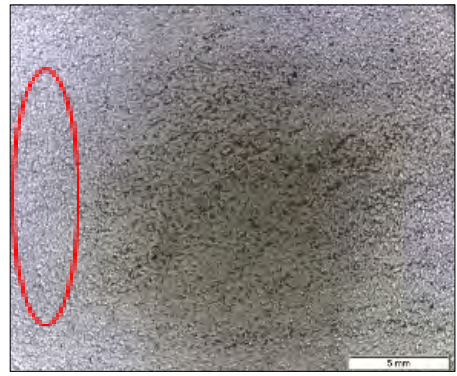
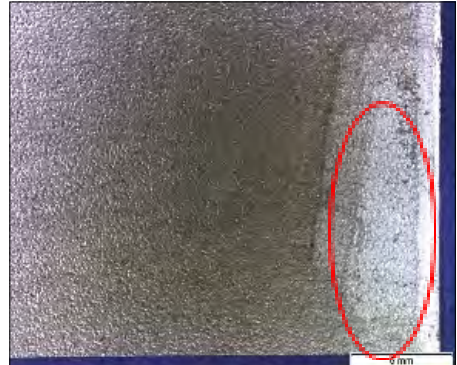
Figure 11. Scratched (upper) and wire-brushed 2304 specimens after two months, scale is 5 mm.

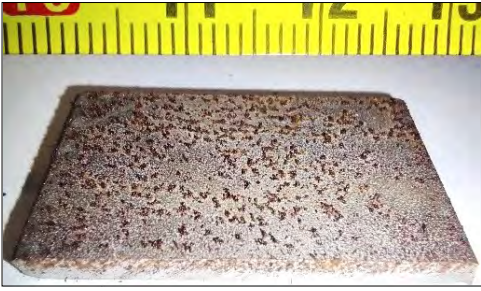
The rust that forms on the surface of the specimens is loose and can be easily wiped off the sur-

Figure 12. The 1.4404 specimen surface after two months.

face of the specimen, which will roll off with little force (Figure 12). The difficulty of repair is due to pitting corrosion of the surface.

It can be observed that the amount of rust deposited on the surface of the sample increases with time, and with it the number and depth of pits on the surface.
