# OCCURRENCE OF VINE GREY-COLOURED RELIEFS ON THE BAROQUE FAÇADES OF MODERN-DAY SOPRON

Sándor TÁRKÁNYI

During the renovation of the façades of historic buildings in the Baroque old town of Sopron, researchers have recently found traces of vine grey paint on several occasions on stone carvings. One of the earliest occurrences of this colour dates back to the Jesuit reconstruction of St. George Church in 1714. In the following decades, the natural pigment produced by burning vine twigs, mixed with lime, was also used on the Esterházy Palace and several residential buildings in the city centre. This study presents four façade renovations where the original Baroque colouring was restored as a result of the reconstruction process.

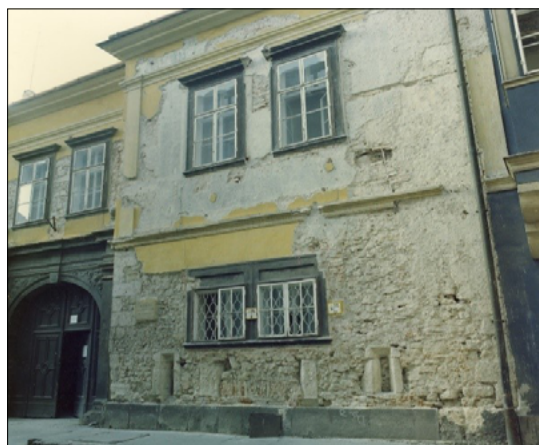
**Fig. 1.** The façade of the building at 4 Templom Street during the exploration process in 1986 (Photo by Galacanu Efstatia).

Ferenc Dávid and completed by Judit G. Lászay. The research conducted between 1986-1992 clarified the architectural history of the house and explored quite a great number of valuable medieval details in the building (see Fig. 1). The archaeological work was led by archaeologist János Gömöri. During the restoration, on the surface of one of the upstairs street-facing rooms of the north wing, a late medieval quadratic wall painting made with secco-technique was restored, at the same time on the first floor of the south wing a joint medieval window was reconstructed. Renovation plans were prepared by architect Judit M. Kaló, who published the restoration process of the building in the first volume of *Műemlékvédelem szemle* (Journal of Historic Building Protection) in 1993. On the front page of the journal a colour photo of Templom Street, Sopron was published with the restored Esterházy Palace, where the dark grey colour of the gate's and windows' stone frames could also be seen on the light rose, sgraffito façade. [3] As far as I know, this was the first building in Sopron among those restored by the NMC where the vine grey colour that had been found on the front during the research process was reconstructed. According to Judit G. Lászay, *„The frames were originally black, painted by charcoal, however, the motifs of the friezes representing vine-tendrils and clusters of grapes were colourful. A few – but not enough for reconstruction – yellow, ochre and green pigments remained on the surfaces.”* [4] The above statements suggest that the contemporary appearance of Palatine Miklós Esterházy's building must have been most characteristic and attractive.

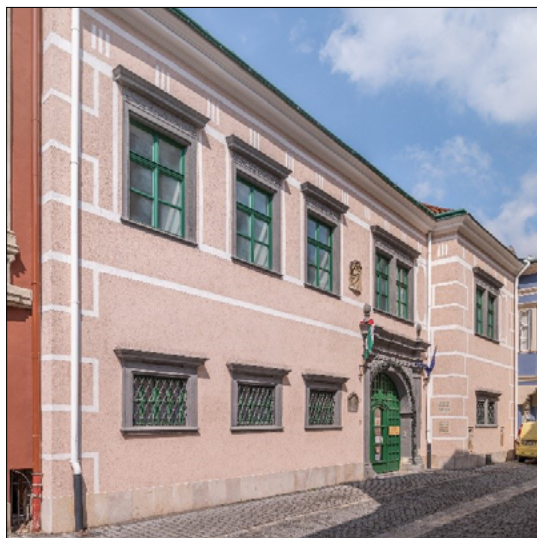
**Fig. 2.** The façade of the building at 4 Templom Street, restored in 2019 (Photo by Richárd Tóth and the Author).

The street-facing façade's damage map as well as the plans of its renovation were prepared by architect Szilárd Fekete in 2016. The restaurateur's proposal concerning the stone carvings was submitted by sculptor-restaurateur József Sütő in 2019. [5] Since the restoration of 1993, the plaster has been damaged in a cca. 0.5 m stripe above the footing zone. Out of the stone carvings, the gate stiles and the stone frames of the two medieval niche windows showed some signs indicating corrosion. During the renovation, those window frames that were located above the level of subsoil water and the absorption limit of salts were first cleansed with low-pressure dry microgranule dispersion. After this, their surfaces were firmed by a diluted solution of silicic acid-ester conserving agent, while the smaller gaps were filled with restaurateur's mortar. The cleansed, firmed and filled stone carvings were coated by vine grey toned silicate hiding paint (see Fig. 2.).

On the footing elements of the gate (both on the right and left side) as well as on the curb stones salts sweated out to an extremely great extent, and the supply of salts was continuous. The architectural plan prescribed the demolition of the stone carvings and their recarving by masking, with a thickness of 10 cm. The new carvings were made of the same material as the previous ones, that is, limestone from Fertőrákos. Before being replaced, the stone stump that had remained in the wall structure was insulated, then the new elements were firmed, and the joints were caulked. The restored gate structure was coloured the same way as the stone-framed windows.

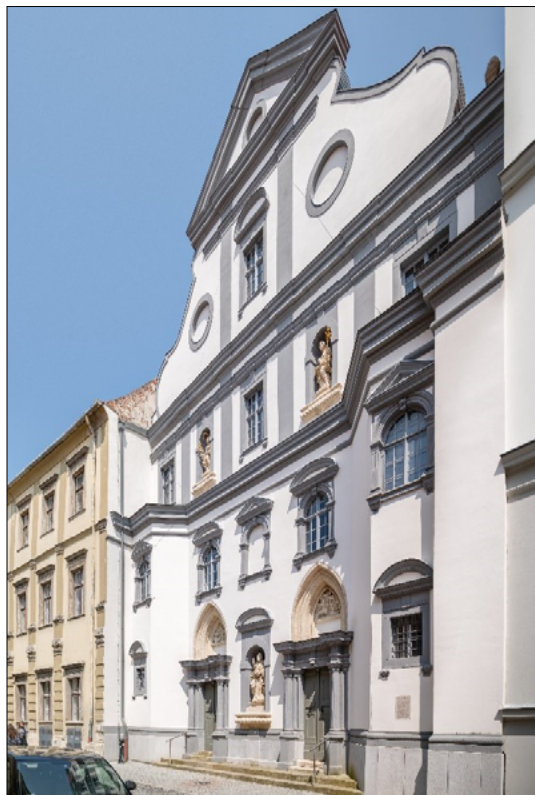
**Fig. 4.** The restored street-facing façade of St. George Church (Photo by Richárd Tóth and the Author).

The restoration plans of the church's Baroque main façade were prepared by architect Attila Jakab. The probing painter-restaurateur's exploration revealed that during the 1961 restoration of the façade a complete plaster exchange had been carried out. Nevertheless, during the 'careful' cleansing of the stone-carved window frames, the former traces of paint remained on several areas. [9] Generally speaking, the following coats of paint were explored by the researchers: (1) white-colour whitewashing as undercoat, (2) dark grey whitewashing, (3) lighter, warm grey whitewashing, (4) 4-5 layers of white-colour whitewashing, (5) green colouring, (6) ochre whitewashing, (7) pastel yellow whitewashing, (8) red whitewashing from 1961, (9) plastic-based red façade colouring.

To sum up, it is evident that the red colouring applied in 1961 on the reliefs appearing on the white façade had no historical antecedents. At the time of the earliest façade shaping, the architecture standing out from the white-coloured, white-washed surface was coated by dark grey (vine grey) whitewashing. This way of colouring fitted in the colouring routine of the age, as for Jesuit churches.

To meet the architect's request, the painter-restaurateurs examined the coat of paint of the church's windows and doors with some tiny sondes. The earliest revealed layer was an oil coating coloured by copper green, which was painted directly on the surface of the wood. However, during the renovation of 2017, the doors and windows of the façade were coated by a darker and warmer tone of grey than vine grey (see Fig. 4).

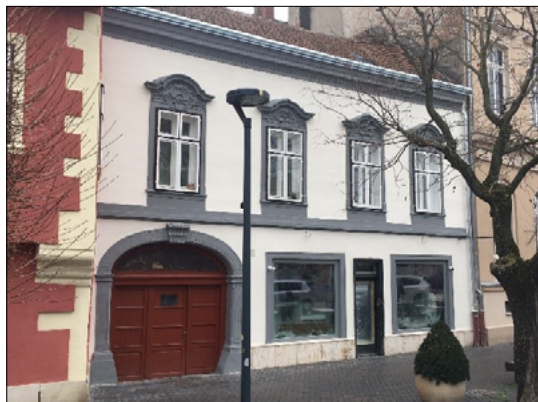
Fig. 5. The restored street-facing façade of the building at 57 Várkerület (Photo by the Author).

The renovation plans of the Várkerület-facing façade of the residential house (owned by the municipality of Sopron) were prepared by architect Attila Jakab. The ground floor of the building was previously covered with non-breathable heat-insulating panels, and on the first floor the coat of plaster was already missing from quite large areas. After the façade scaffolding, the contractor did some research on the Rococo stone carvings and revealed that their earliest coat of paint had also had dark grey colour. The renovated front side

of the residential house was painted off-white, while the stone carvings were given vine grey colour (see Fig. 5.).
